POTENTIAL HAZARDOUS WASTE SITE
PRELIMINARY ASSESSMENT

Champion International Corp.
Site Name

NYD089756340
EPA Site ID Number

02-8607-04
TDD Number

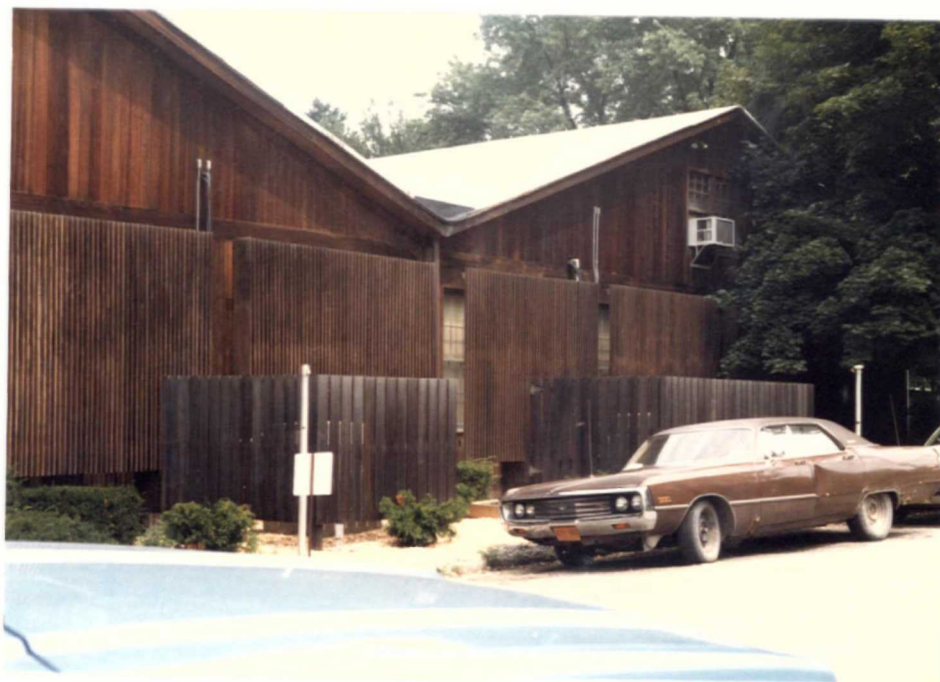
1P-26 August 7, 1986 1429
Looking north from Coldenham Rd. shows office of Champion International.
Photographer: Jack Taylor.

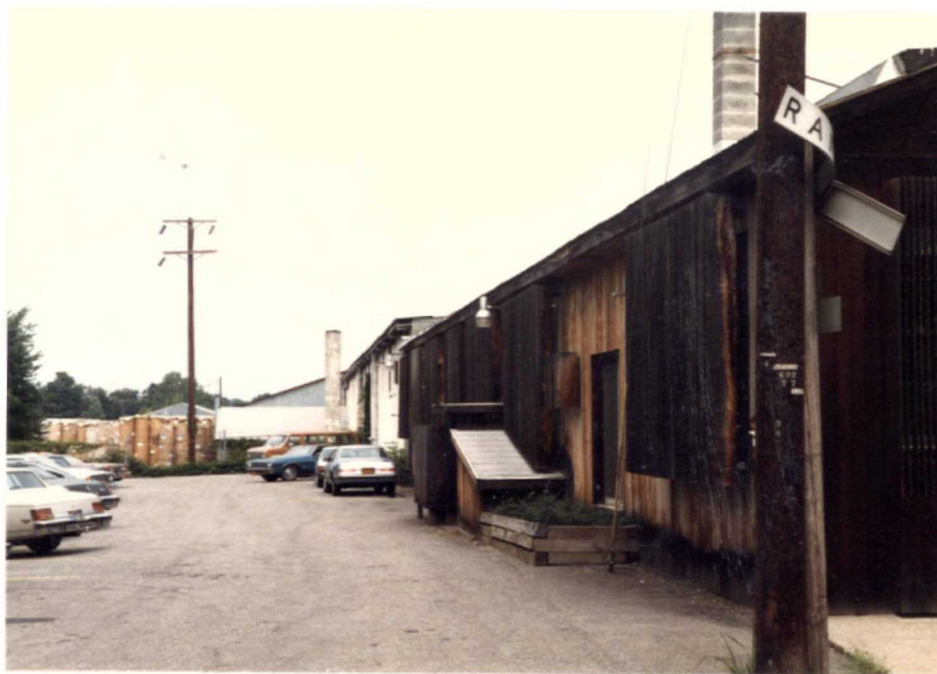
1P-27 August 7, 1986 1429
Looking north from Coldenham Rd. shows parking lot and storage area.
Photographer: Jack Taylor.

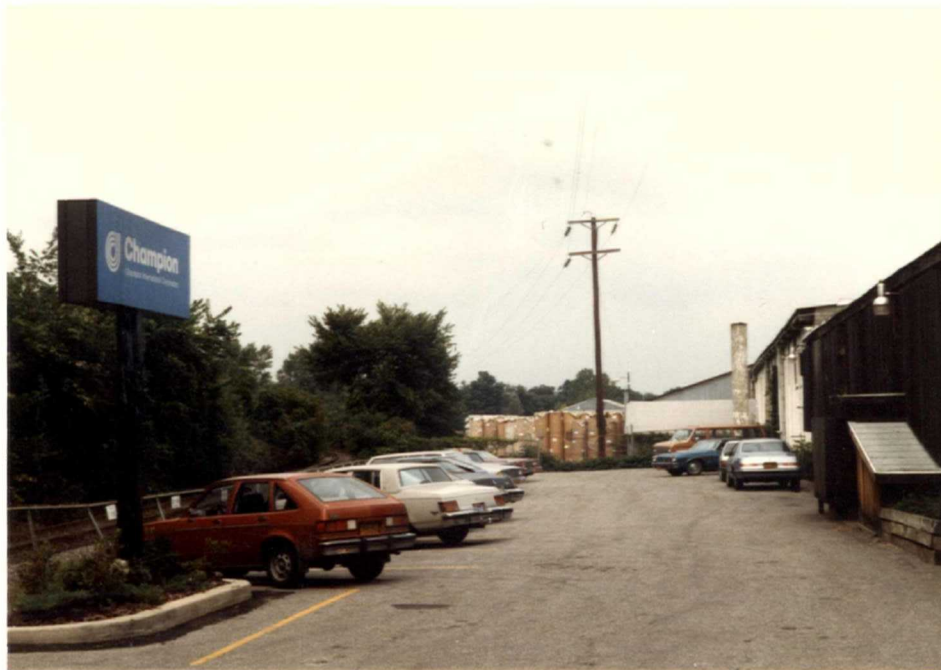
1P-28 August 7, 1986 1430
Looking north from Coldenham Rd. shows storage area with tracks
just to the west.
Photographer: Jack Taylor.
